ANALYZE YOUR WAY TO LONGER LASTING, BETTER PERFORMING V-BELT DRIVES

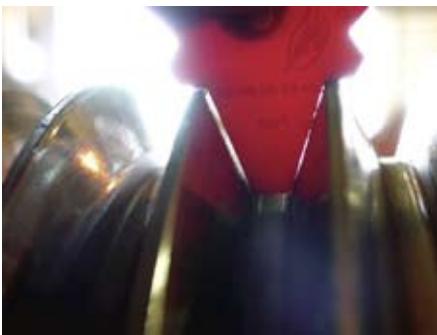
Figure 5 - Inspect sheave grooves for wear with a plastic groove gauge, available from most belt manufacturers.

Always check sheaves for wear and damage before mounting a V-belt. Nicks and sharp edges can damage belts. So can worn sheaves. Using a plastic groove gauge is a simple method to check for wear (See Figure 5). If the clearance between the sheave and groove gauge exceeds 1/32 inch, replace the sheave.

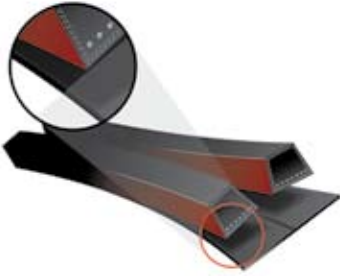
Figure 16- Tie-band separation

Tie-band separation (See Figure 16) might be the result of improper groove spacing. Check the sheaves to ensure that they have been manufactured to industry specifications. Another cause might be worn or incorrect sheaves, which requires replacing the sheaves. Also check to see if the sheaves are misaligned, which could force a separation of the tie-bands. Realign the drive to correct the problem.

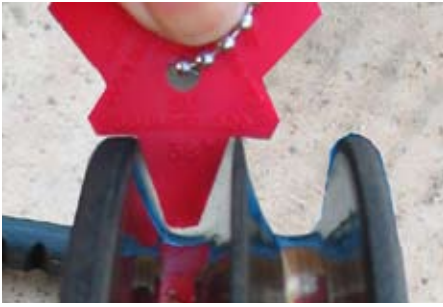
Figure 20 - An investigation into a customer's belt failure complaint identified this severely worn sheave.

It seems improbable that a rubber V-belt could wear out a metal sheave, but it's a fact (see Figure 20). Many users replace V-belts several times without bothering to check the sheaves for wear. Signs of sheave wear include groove sidewall cupping and/or a polished groove sidewall with ridges. Use a sheave gauge (See Figure 21) to detect excessive sheave groove wear, and replace sheaves immediately when worn.

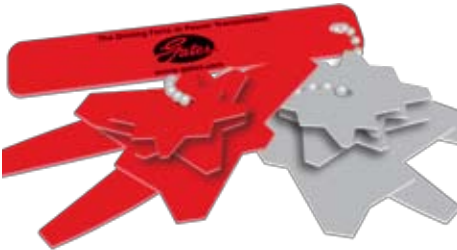
Figure 21 - Gates sheave gauge, product number 7401-0014
